NATIONAL REGISTER OF HISTORIC PLACES
INVENTORY - NOMINATION FORM

1. NAME	
COMMON: Bowlingly	
AND/OR HISTORIC: From 1798 for a brief period, "Neale's Residence"; from 1905 to 1914, "The Ferry House"; 1914, reverted to Bowlingly;

Bowlingly: The Granary
QA-7
7133 First Avenue, Queenstown
History Matters, LLC
August 2007
Sections 3, 4 Page 1

Bowlingly: The Granary
QA-7
7133 First Avenue, Queenstown
History Matters, LLC
August 2007
Continuation Sheet
Section 7 Page 1

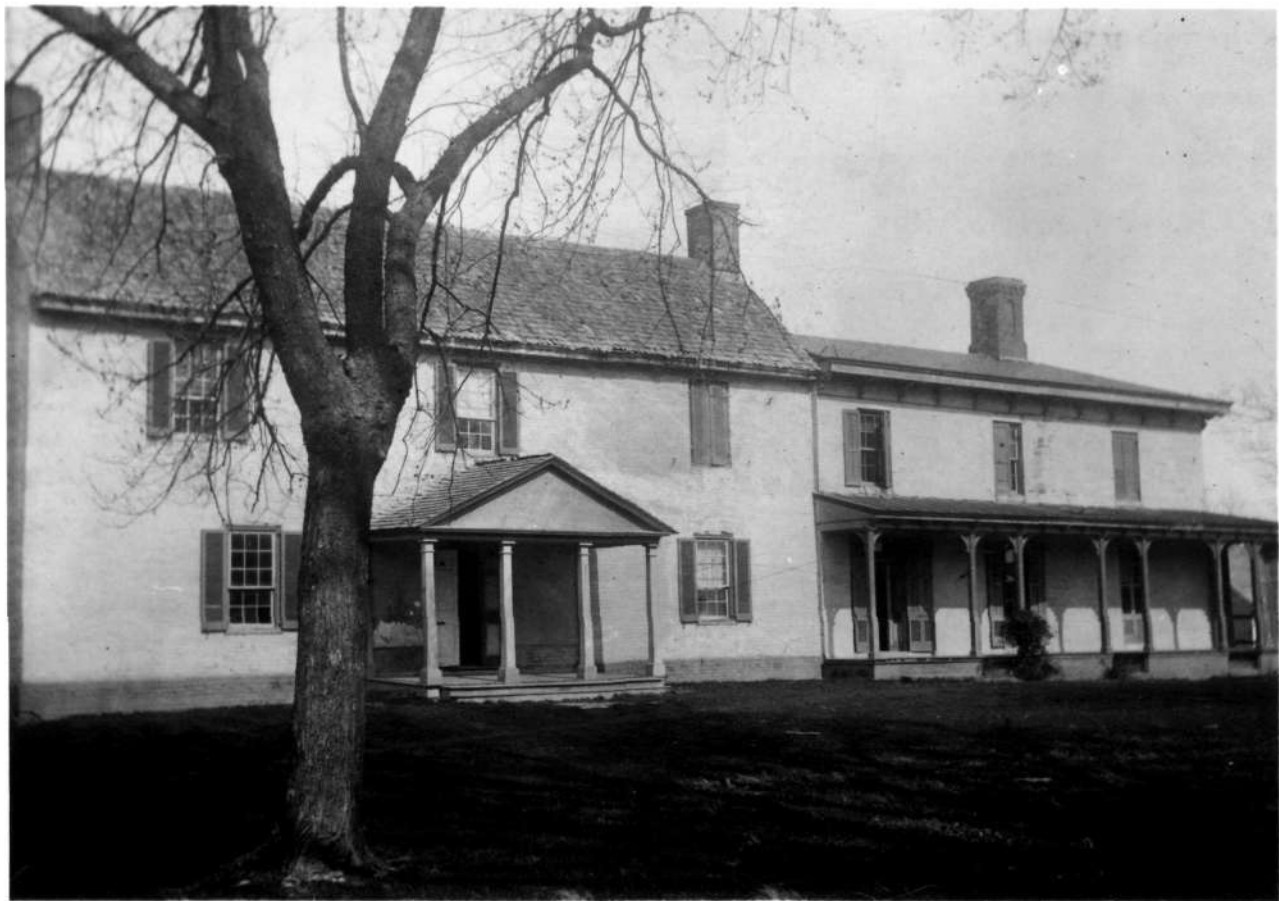
QA-7, BOWLINGLY

GA-7
The House at "Bolingly" in Queenstown before the alterations done by the Railroad. This picture was probably taken about 1890. The Mitchells sold "Bolingly" in 1895.

In about 1895, Bowlingly began a brief period of use as a hotel, and became known as "The Ferry House". It served to take care of the passengers who arrived from Baltimore by ferry to the Bowlingly wharf, whence transportation to Easton existed via a narrow gauge railroad. The hotel management did great damage by installing 220 feet of covered porch around the house at the level of the string piece, knocking off the two top courses to hold the roof of the "piazza".
